MANUFACTURING TECHNOLOGY

JOURNAL FOR SCIENCE, RESEARCH AND PRODUCTION

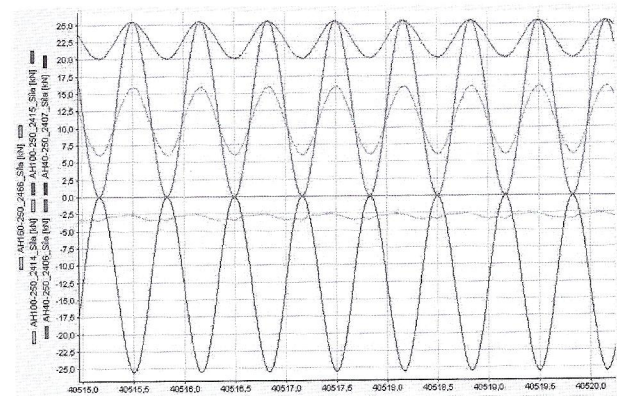
Fig. 2 The loading in software TestControl

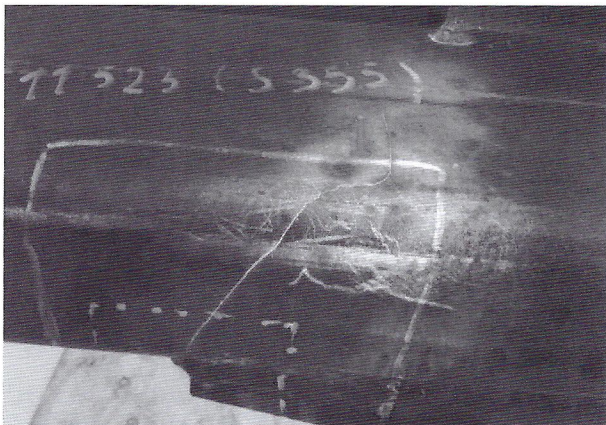
Fig. 3 The longest linear indication after 1 200 000 cycles

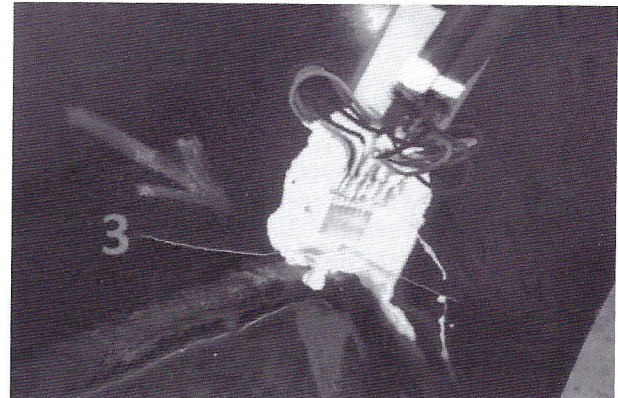
Fig. 4 Detail of the linear indication near the strain gauge after 1 200 000 cycles

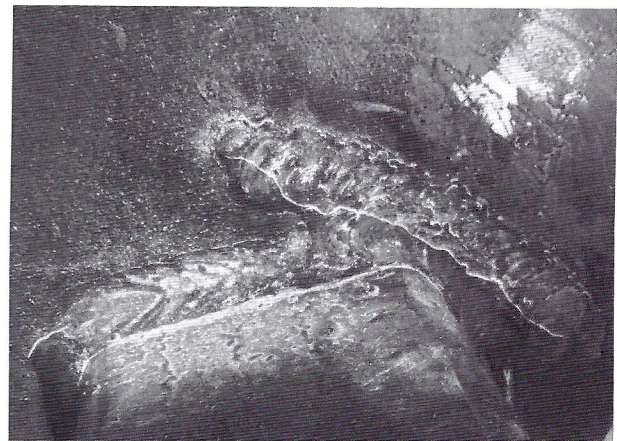
Fig. 5 Detail of the linear indication, repaired after 1 200 000 cycles, after 1 500 000 cycles occurrence again in weld

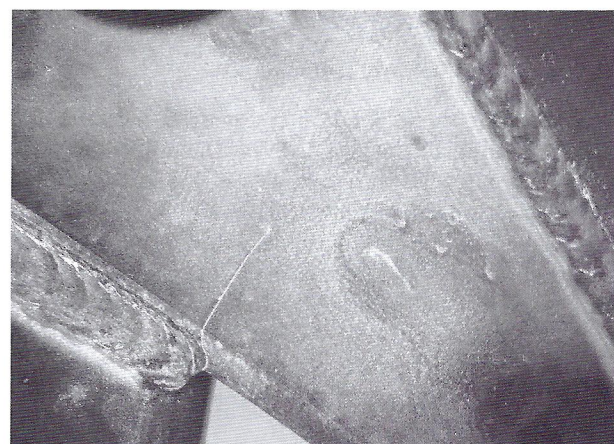
Fig. 6 Detail of the linear indication after 1 500 000 cycles

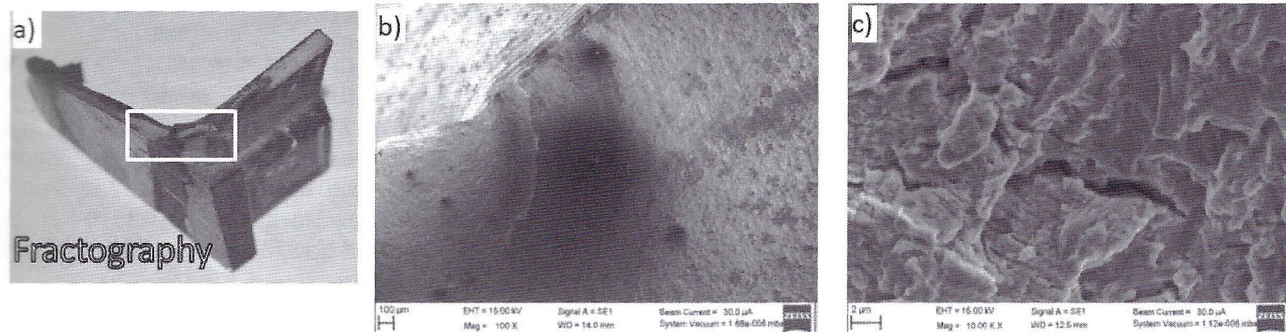
Fig. 7 Part of the crack with failure initiation area cut from the frame, (a) overview of fracture surface with initiation area marked by a white rectangular, (b) detail of the fracture initiation at the surface of the frame, (c) detail of fracture surface with striation created by gradual propagation of a fatigue crack and secondary cracks.

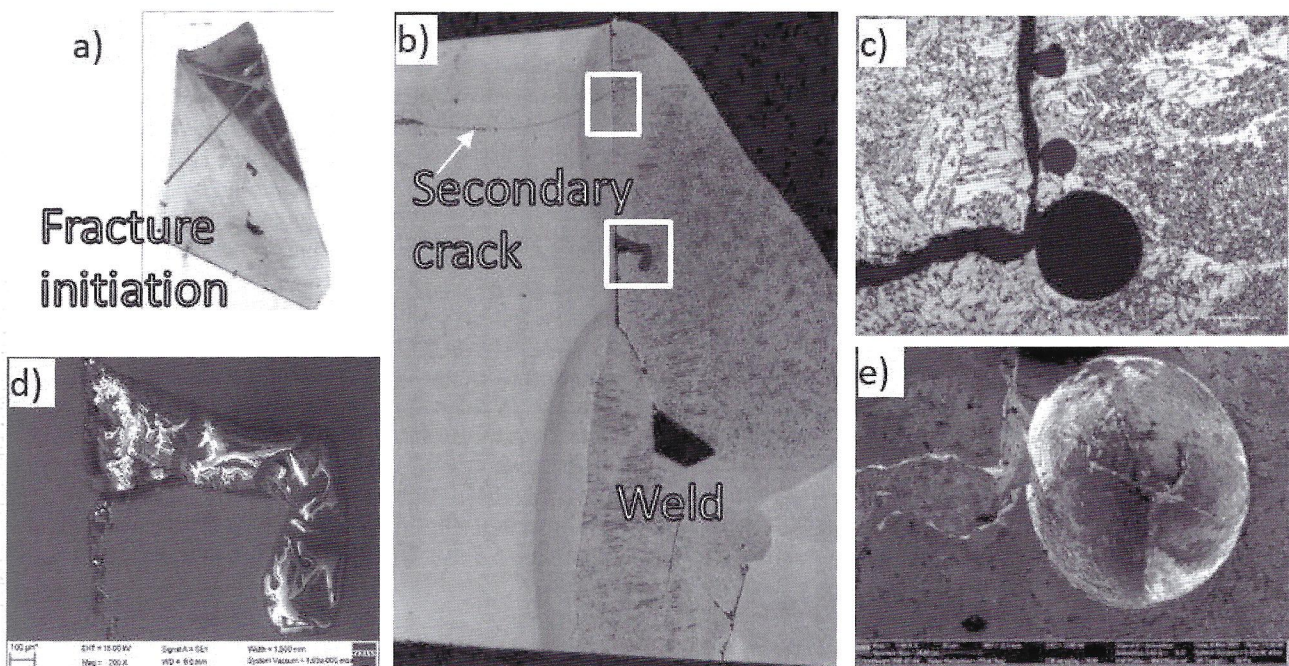
Fig. 8 Metallography of the cross section perpendicular to fracture surface, provided in the area of crack initiation. (a) part of the frame for metallographic analysis, (b) macro of etched cross section, areas of defects found at the weld-base metal interface marked in white rectangles, (c) detail of the upper defect with initiation of secondary crack from the spherical defect, (d) detail of the “crank” shaped defect, (e) detail of spherical defect from Fig. 7(c).
