The Castle in Sztum in the Light of archaeological research in 2019

Bogusz Wasik

Abstract: *The article presents the results of research of the Teutonic castle in Sztum that was carried out in 2019. This was the first large-scale study of this stronghold. It yielded much information, verified past views and supplemented existing knowledge significantly. The presence of a wooden-earthen stronghold in the place of a brick stone castle was not confirmed, and a new chronology of the beginning of its construction was indicated at the end of the 14th century. Elements of the castle's buildings were discovered and identified, such as the residential building of the Grand Master and the second castle gate. The state of knowledge about the castle construction technique has also been significantly expanded.*

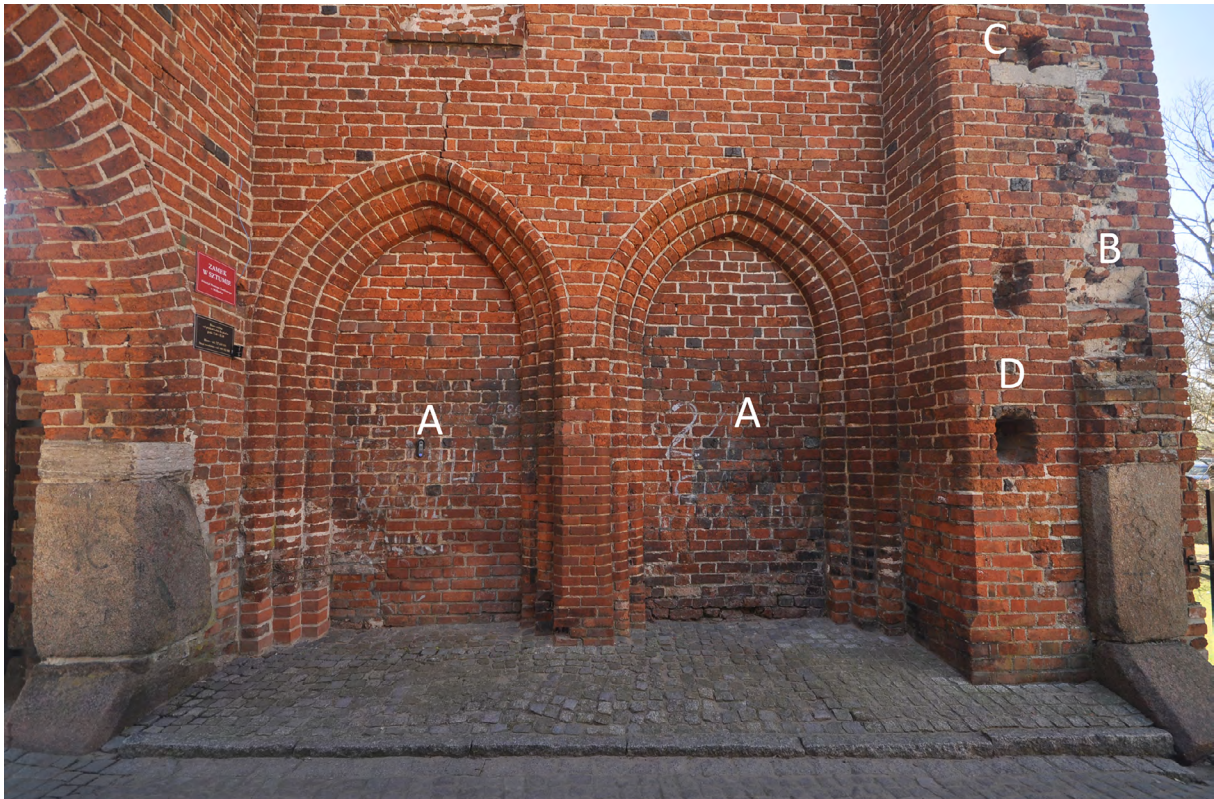
Fig. 4. South wall of the west gate: A – niches, B – demolished wall of the gate passage, C – place of support for the beam lifting the drawbridge, D – holes of beams bolting the gate (photo B. Wasik).

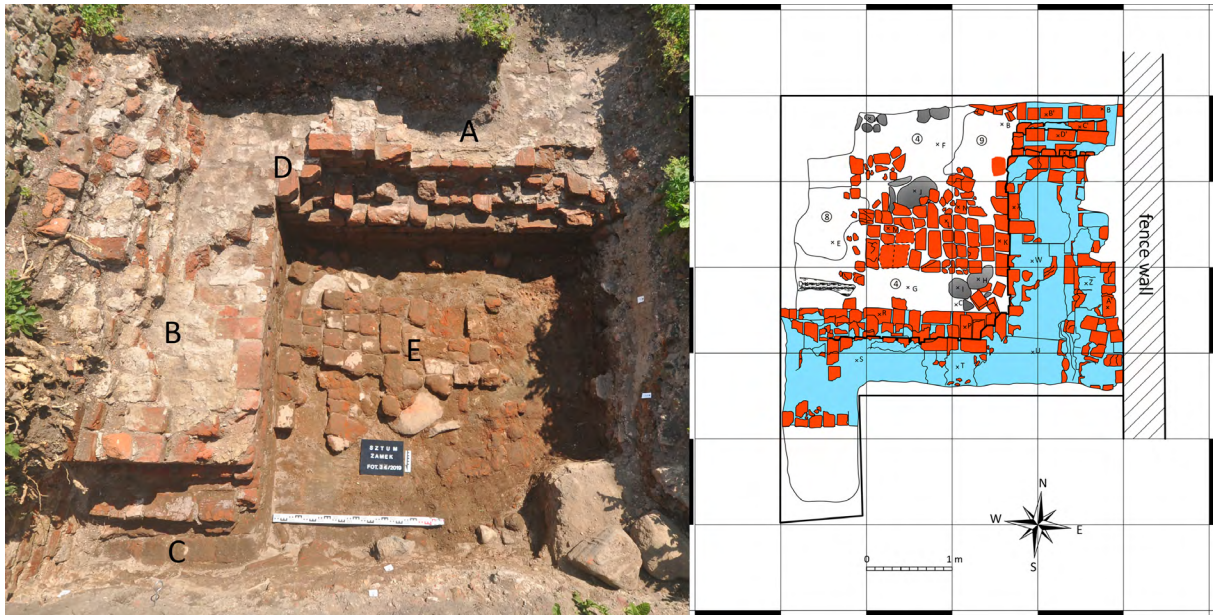
Fig. 5. Trench 5a – remains of the eastern tower and the gate: A – tower wall, B – castle perimeter wall, C – gate opening, D – niche jamb, E – floor of the gate building (photo B. Wasik, drawing S. Urbaniak, digit. B. Wasik).

of the eastern tower wall and the castle perimeter wall showed that both are linked and built at the same time (Fig. 5; Wasik 2019a, 69–70). Moreover, architectural studies from 1980–81 showed that the western and northern towers (the latter of which served as a prison) are also linked to the castle’s perimeter wall (Mincer – Labeuz – Specht – Żabiński 1981, 42; Rekowśka 1980, 100), which is also confirmed by current observations. Therefore, suggestions about the secondary nature of one of the towers should be rejected, and it can be stated that all three were built together with the defensive wall as part of a uniform concept of the castle’s appearance. This is also confirmed by the analysis of the brick size.¹ Building material of a similar size was used to erect defensive walls, towers and gates, which differs from the material used in other buildings erected in the later stages of the castle’s construction (Wasik 2019a, 111). As for the chronology of the castle construction, pottery shards found in the construction embankment that connects with the filling of the foundation ditch of the southeast wall have features indicating the second half of the 14th century. In addition, late-medieval ceramics, occurring in the castle layers in general, have features typical of the chronological interval from the mid-14th to mid-15th century (Błędowski 2019; Wasik 2019b, 117). Also, the architectural elements of the castle reveal features that point to a later chronology of the construction than was previously and most commonly accepted. The castle gates have an unusual form – they consist of a gate building connected to a square tower (Fig. 6–7). Such gates flanked by a tower occur in the areas along the Oder and Elbe rivers. Meanwhile, the most typical form in Prussia, as well as in the Polish Crown, was a four-sided tower with a gate in the ground floor (Widawski 1973, 56–60). A close analogy, with characteristic niches in the side walls of the gateway, are the city gates of Nowe Miasto (Germ. Neumark), especially the Lubawska Gate. There are no written sources specifying their chronology, but already in the 19th century Johannes Heise pointed to the stylistic and workshop similarities to the gable of the Lubawska Gate tower and the main nave of the parish church of St. Thomas (Heise 1895, 671–673). The expansion of this church can be dated to the third quarter of the 14th century (Herrmann 2007, 621). Another characteristic element is the prison tower – strongly extended with

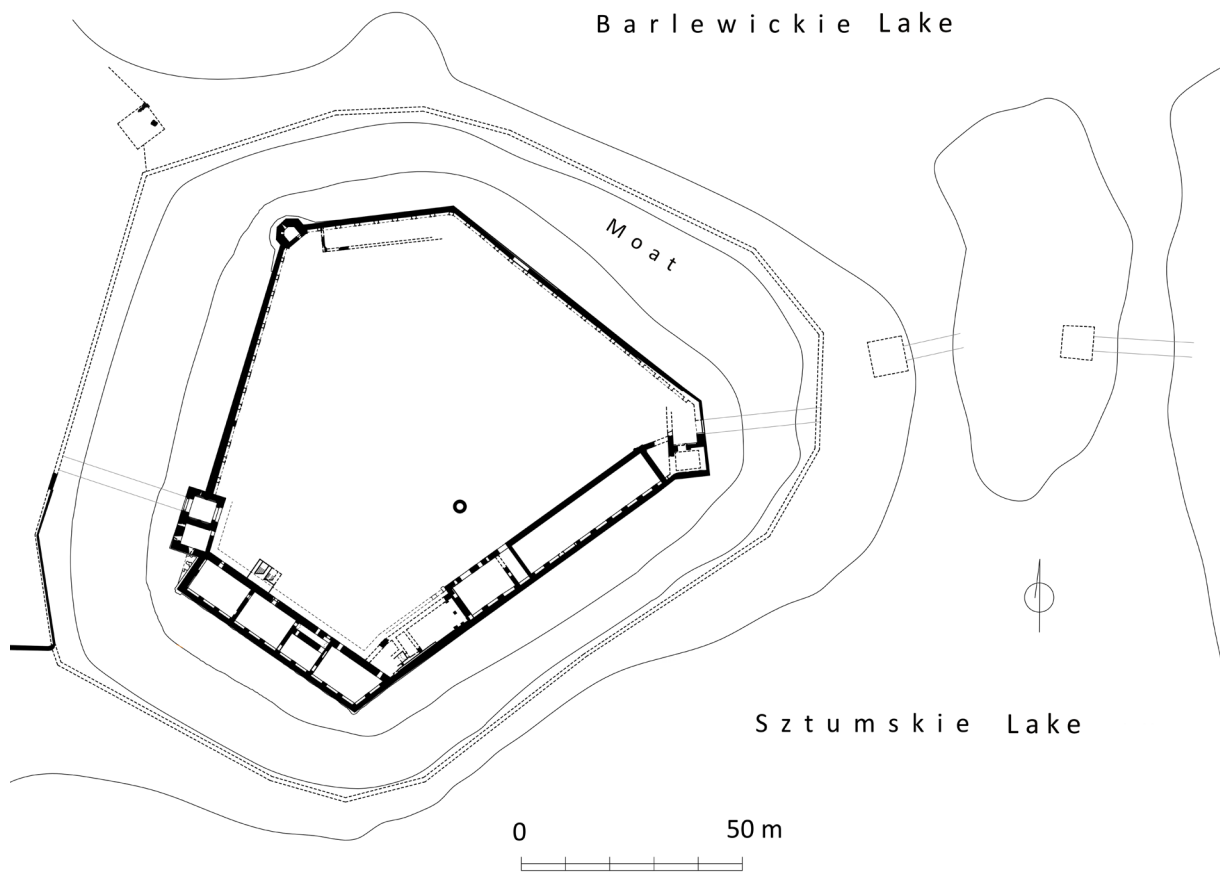
Fig. 6. Reconstruction of the castle plan in the first half of the 15th century (by B. Wasik).

The castle was built on an irregular, polygonal plan, which for the end of the 14th century should be considered unusual, even anachronistic (Fig. 6). For a hundred years, the castles

9.8 m above the medieval level of the courtyard (nearly 9 m above the current one;⁶ Wasik 2019a, 88, 90). Three towers were in the line of the perimeter wall (Fig. 6). As indicated earlier, they were all built along with the defensive wall. Their walls are linked, and as the analysis of the brick sizes showed, similar building material was used to erect the brick parts of the towers and the defensive wall, other than in buildings from the later stages of the castle construction (bricks approx. 90–100 × 140–150 × 300–320 mm; Wasik 2019a, 111). The east and west towers were quadrilateral, and the north prison-tower polygonal. None of the towers retained its original height – they were demolished and lowered at the end of the 18th and the beginning of the 19th century. However, their sizes can be determined on the basis of early modern descriptions and iconography⁷ (Fig. 11). On this basis, it can be concluded that the western tower was the highest, with eight storeys according to the description (*Lustracja 1615–1624*, 280). Thus, its height can be estimated at about or slightly over 30 m (Fig. 3, 7). According to iconography, the eastern tower was slightly lower, but there is no more accurate information about its height. The prison-tower was the lowest (Fig. 7.) Researchers suggested that it had four (Bergau 1869, 409) or five storeys (Töppen 1881, 98). However, these calculations are based on weak premises⁸ and should be treated with caution and approximation. It should be noted that only the last of the mentioned towers had clear defensive value. In the lower part, it had a dungeon, and on the upper floors the embrasures were arranged so as to enable the effective defence of the castle's foreground. The tower was also located in a place allowing control of the causeway to the north side of the castle, as well as the entrance to the city. The other two towers, however, had, as can be seen in their ground floors, walls only about 1.7–1.8 m thick, with a fairly large interior. Considering the height of about 30 m, it should be stated that the walls on the highest floors clearly had to be thinner. In the 16th–17th centuries, both quadrilateral towers held housing premises – the western starost's rooms (*Lustracja 1565*, 168–169; *Lustracja 1615–1624*, 280, 282). In the Middle Ages, they also most probably had residential interiors. This evokes analogies of the Klesza Tower in the Malbork castle, which housed the apartments of priests (Jóźwiak – Trupinda 2011, 514–115).

Both quadrilateral towers were connected with lower gate buildings (Figs. 6–7). The west gate (leading from the city) is still partially preserved today. It was preceded by a wooden bridge, at the foot of which (in the line of the outer wall of the moat) there was a small gate. At the gate proper, there was a drawbridge lifted by chains (*Lustracja 1565*, 166; *Lustracja 1615–1624*, 278). As the trace of the dismantled arch of the gate (on the preserved southern wall) is retracted in relation to the building face, it can be assumed that the gate opening was in a higher niche (Fig. 4). Nearly 5 m above the ground, there is a horizontal stone on which the beam lifting the drawbridge probably rested. Above it, there is no trace of a wall, which indicates that the beam, when raised, probably fit into a vertical narrow opening in the wall (cf. Domańska 1971, 19). The existence of a second gate with a drawbridge from the east was indicated by early modern descriptions and iconography (*Lustracja 1615–1624*, 282). Surprising, however, was the discovery at the eastern tower of a second large gate, which was analogous to the preserved western one (trench 5a; Fig. 5). It must be mentioned that both gate-buildings were built along with the neighbouring towers in the first stages of the castle's construction. The dimension of the gate-building on the north-south axis is not yet known, but its width on the east-west line is the same as that of the neighbouring tower (Fig. 6). Within the building, there are also remains of niches in the side wall, analogous to those existing in the west gate. These features indicate that it was not a small gate (wicket), but a full-scale gate-building. The presence of two large gates is unusual for a castle with a basic, single-part spatial arrangement, as it weakened its defences.

Another very large building with utility functions stood in the southeast (Fig. 6). It has survived to this day, but was largely rebuilt in the 19th century and has lost its original appearance. It measured about 10.8 × 54.9 m. In the 16th–18th centuries, on the ground floor, it housed a kitchen, brewery and bakery (counting from the southwest) along with side rooms (Lustracja 1565, 167; Lustracja 1615–1624, 281–282). Interiors with these functions are already mentioned in medieval sources (Józwiak – Trupinda 2017, 49) and, in the light of current knowledge, there is no basis to look for their location in a place other than the one from the early modern period. Above the described rooms, along the entire length of the building, there were two granary floors (Lustracja 1565, 168; Lustracja 1615–1624, 282). This building is identified as a brick-stone granary, which was built in 1400–1403 (Domańska 1971, 25; Pawłowski 2007, 12). Research has shown that this building was extended to the eastern tower in the Middle Ages (Wasik 2019a, 70–71). In 1615, in the ground floor extensions, there was a small stable (Lustracja 1615–1624, 282). Regarding the utility buildings, it should be added that there is information about the demolition of a granary in 1415 in medieval sources (Józwiak – Trupinda 2017, 49–50). However, the location of that building cannot be determined.

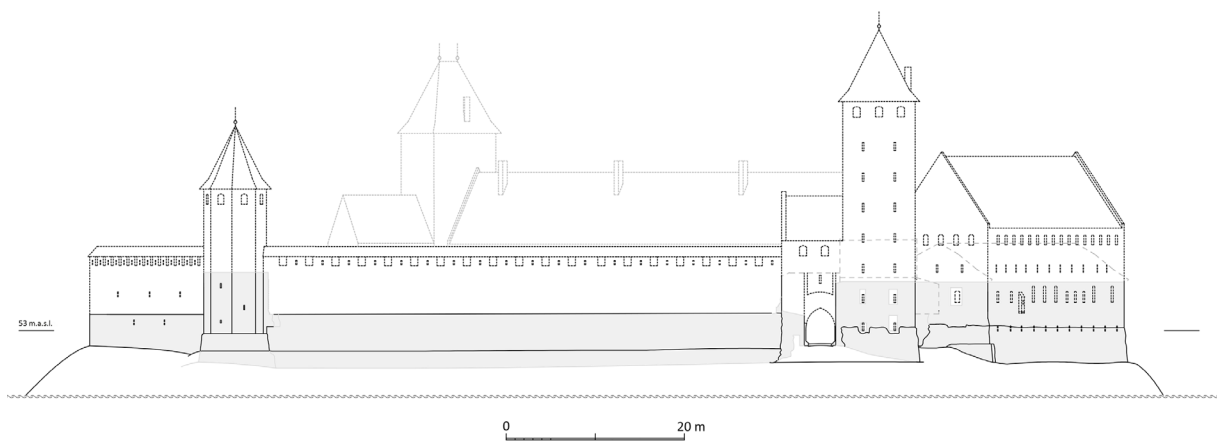
Fig. 7. Reconstruction of the medieval cubature of the castle, indicating the preserved walls (grey) and the originally higher ground level of the western moat slope – view from the west (by B. Wasik).

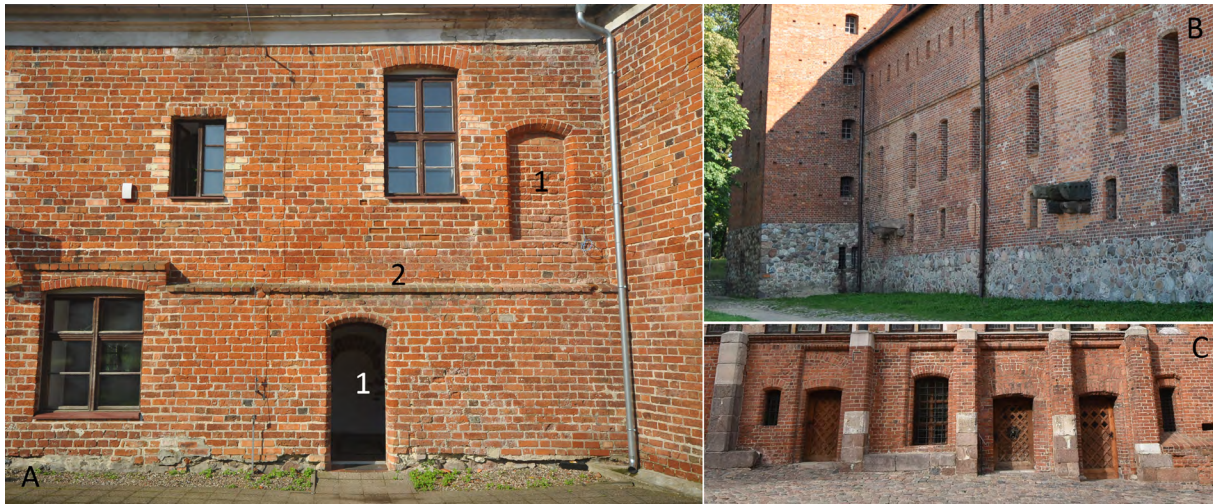
Fig. 8. Fragment of the south-western wing façade (A) with original entrance openings (1) and the offset on the gallery (2). The façade of the castle in Bytów (B) and the ground floor of the Grand Master's Palace in Malbork (C) (photo B. Wasik).

with the custom. However, this indicates the presence of a storey, which probably served as a warehouse in the Middle Ages. It is known from other castles that, in early modern times, housing space (e.g. in Grudziądz; Wasik 2012, 67) was sometimes placed in the warehouse stores above the main (first) floor. Such a room would not be located at the level of the defensive battlement and attic, which had to be above. As for the functions of individual rooms in the Middle Ages, knowledge from written sources is limited. On the first floor, there must have been the rooms of the *vogt*, including a refectory and his chapel (Józwiak – Trupinda 2017, 48–49). Based on the observations above, the *vogt's* wing can be reconstructed as a building with a full basement, with a utility ground floor, a residential-representative first floor, a storage second floor and the highest defensive floor with a storage attic. Early modern views from 1628, 1749 and ca. 1750 show that the building had triangular gables (Fig. 11). Horizontal communication of the rooms on the first floor was provided by a wooden gallery facing the courtyard (Lustracja 1565, 168; Lustracja 1615–1624, 279). A relic of it is an offset in the wall (Fig. 8).

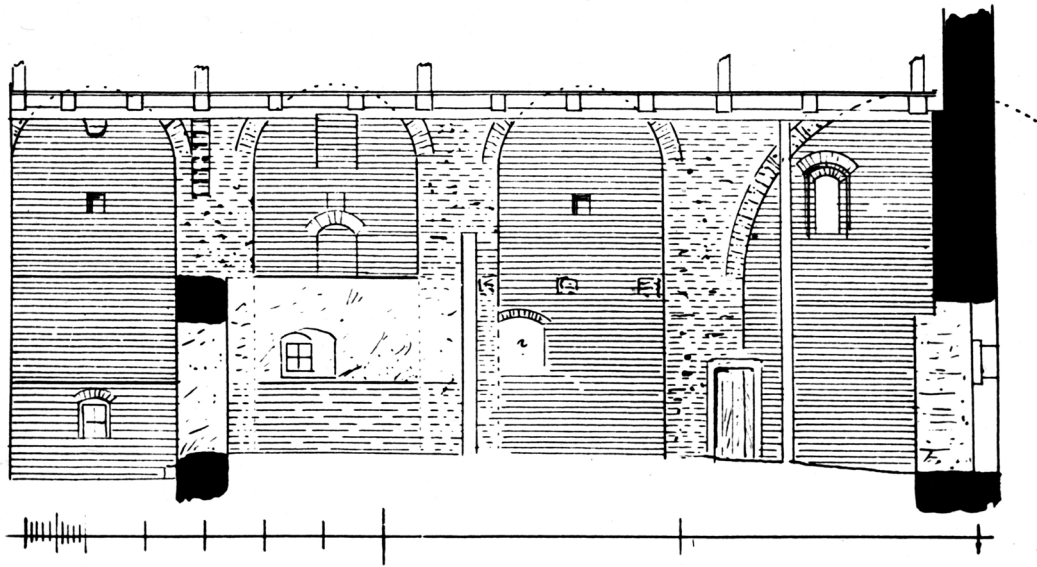
Fig. 10. Arcades of the perimeter wall preserved in the southern part of the south-eastern utility wing (by Schmid 1909).

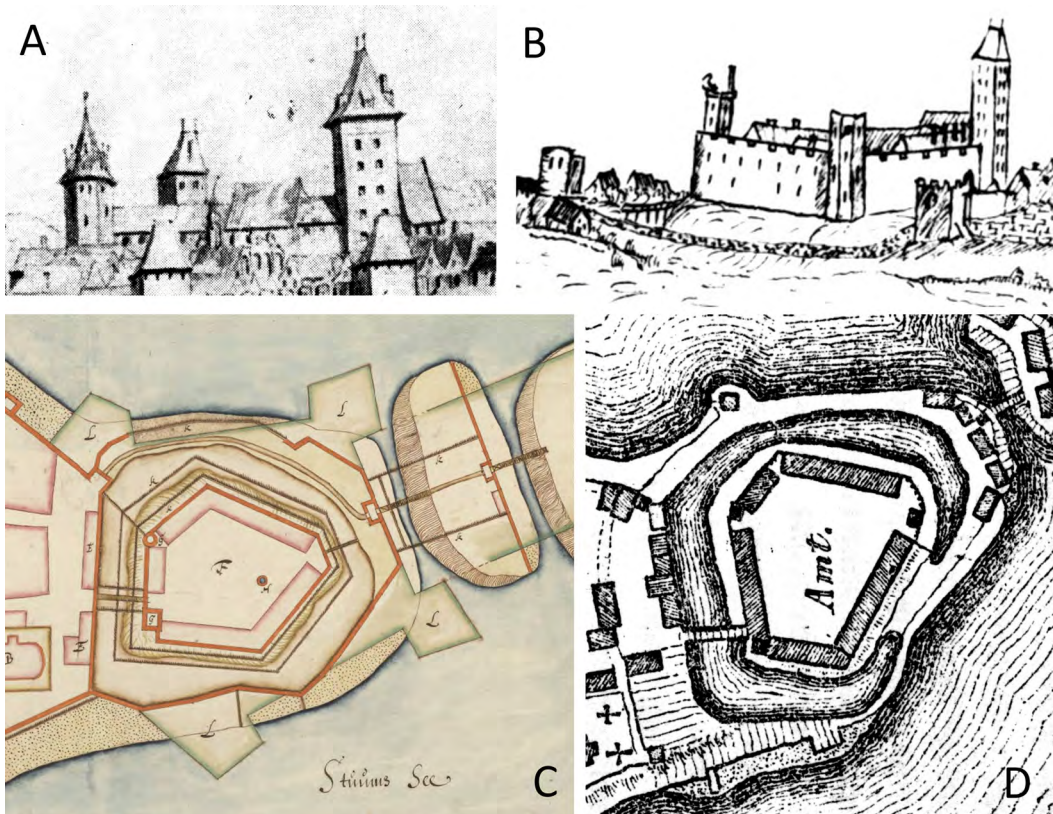
Fig. 11. Early modern iconography of the castle: A – view of the castle from the west; fragment of the panorama of the city and the castle by A. Booth from 1628, B – view of the castle from the north; fragment of the panorama from 1749, C – plan of the castle from 1658; D – plan of the castle by A. Wolf from 1772 (A, B, D by Mincer – Labeuz – Specht – Žabiński – KołECKI 1981; C by Kungl. Krigsarkivet in Stockholm, SE / KrA / 0425/06/011, https://sok.riksarkivet.se/bildvisning/K0024698_00001, accessed 07.10.19).

In the mid-16th century, new utility and residential buildings were erected in the north-east, north and west areas of the castle (Fig. 11). Relics of these objects were covered by archaeological excavations (trenches 4-4a, 4b, 3 and 12; Fig. 1). In the north-east and north, a row of stables was attached to the perimeter wall (Lustracja 1565, 167; Lustracja 1615–1624, 283; Lustracja 1765, 34), which undoubtedly followed the utilitarian function of the place since the Middle Ages. The medieval building discovered in trench 12 was gradually demolished and new and wider stables were constructed (8.2 m). In their construction, the foundation of the medieval western (gable) wall was used and extended (Fig. 13). These buildings were built in a timber-framed construction with brick filling.

Along the western wall of the castle, buildings were erected in the same period of time, housing utility rooms on the ground floor (Fig. 11). The higher floors were devoted to the living quarters and granaries in the attics (Lustracja 1565, 167–169; Lustracja 1615–1624, 282–283). Until now, as indicated earlier, this wing had been mistakenly identified with the residence of the Grand Master. However, archaeological excavations have refuted this. The nature of the archaeological material (pottery, tiles) confirms that the building dates back to the mid-16th century at the earliest (the oldest Renaissance stove tiles come from that time). During the study, remains of point foundations of the timber framed construction of the building wall were discovered in the form of a large boulder and a cluster of stones in a rectangular foundation ditch (Wasik 2019a, 99–100). In the interior, however, the foundation of a four-sided structure with a small interior has been preserved (Fig. 17). This is most likely a remnant of a bread oven, as descriptions from the 16th and 17th centuries mention a bakery in this area (Lustracja 1565, 167; Lustracja 1615–1624, 282).

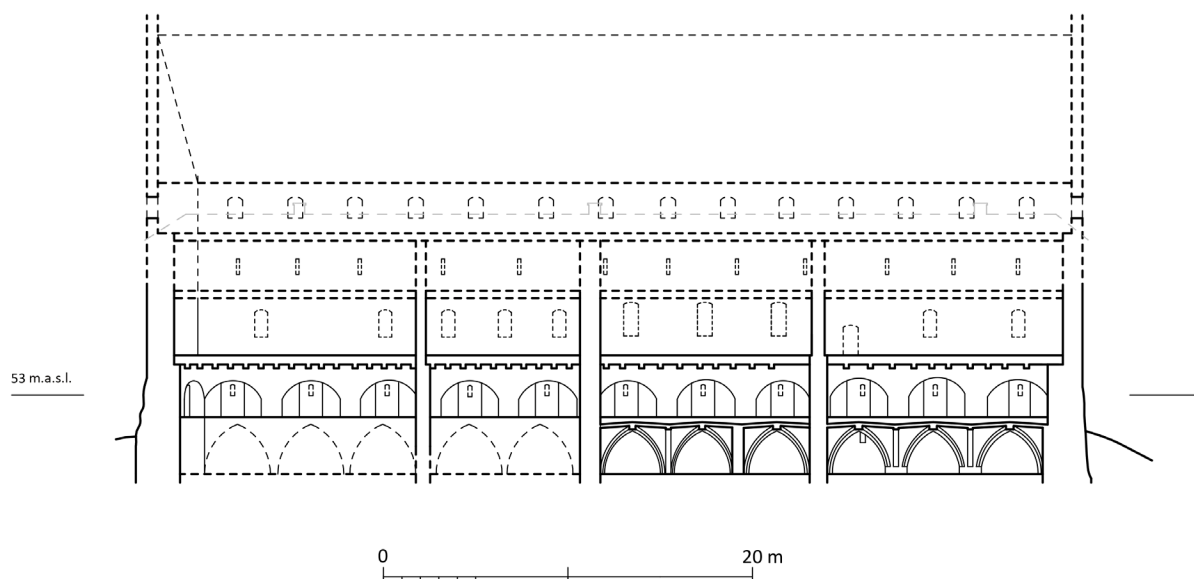
Fig. 12. Reconstruction of the cross-section of the south-western wing (by B. Wasik).

The largest medieval residential building of the castle (about $11 \times 48.8\text{--}52.5$ m) was the south-western wing (Figures 3, 6, 12). Researchers agree that it housed the *vogt* (Domańska 1971, 24; Pawłowski 2007, 11; Schmid 1909, 350; among others). This building, together with the neighbouring west tower, was referred to in medieval sources as *das rechte hus* – the right castle (Jóźwiak – Trupinda 2017, 36–38). As current research has shown, in the castle's first building stage when the foundations of defensive walls, towers and gates were laid, the foundation for the south-western section of the perimeter walls was not made. Perhaps this was not done because construction of the building had already been planned at that time and there was a need to dig wide-spread foundation ditches for its basements. It is certain that the south-western wall was built from the foundation in the second stage of castle construction (initially at least to the level of the window sills of the first floor) parallel to the construction of the upper parts of the defensive walls and towers with gate buildings. Thus, the outer perimeter of the castle wall was closed. Also at that time, the layout of the west wall of the building's gable was changed, giving its plan regularity. At the stage of laying the foundation, it was planned to set it at an angle – exactly on the line of the western section of the perimeter walls. At this stage, the cellars were also built, which is indicated by an analysis of the dimensions of the bricks, which were analogous to those used in the perimeter wall of the castle and in the towers. At present, the cellars are located only under the western half of the building (Fig. 13). However, in the light of early modern descriptions, it can be stated that the south-western wing had a full basement. Further interiors are listed, accessible from the courtyard through another now non-existent staircase (Lustracja 1565, 167; Lustracja 1615–1624, 279). The wall of the ground floor and upper storeys closing the building from the courtyard was added to the existing perimeter walls of the castle in the next construction stage. There, smaller bricks were used ($80\text{--}90 \times 140\text{--}145 \times 310\text{--}320$ mm; Wasik 2019a, 111; 2019b, 114–116, 118). According to early modern descriptions, in the south-eastern part of the currently non-existent second floor of the wing, at least one room was accessible by stairs (Lustracja 1565, 168; Lustracja 1615–1624, 280). However, it is unlikely that housing interiors in the Middle Ages would also be on the second floor of the building, as this was not in line

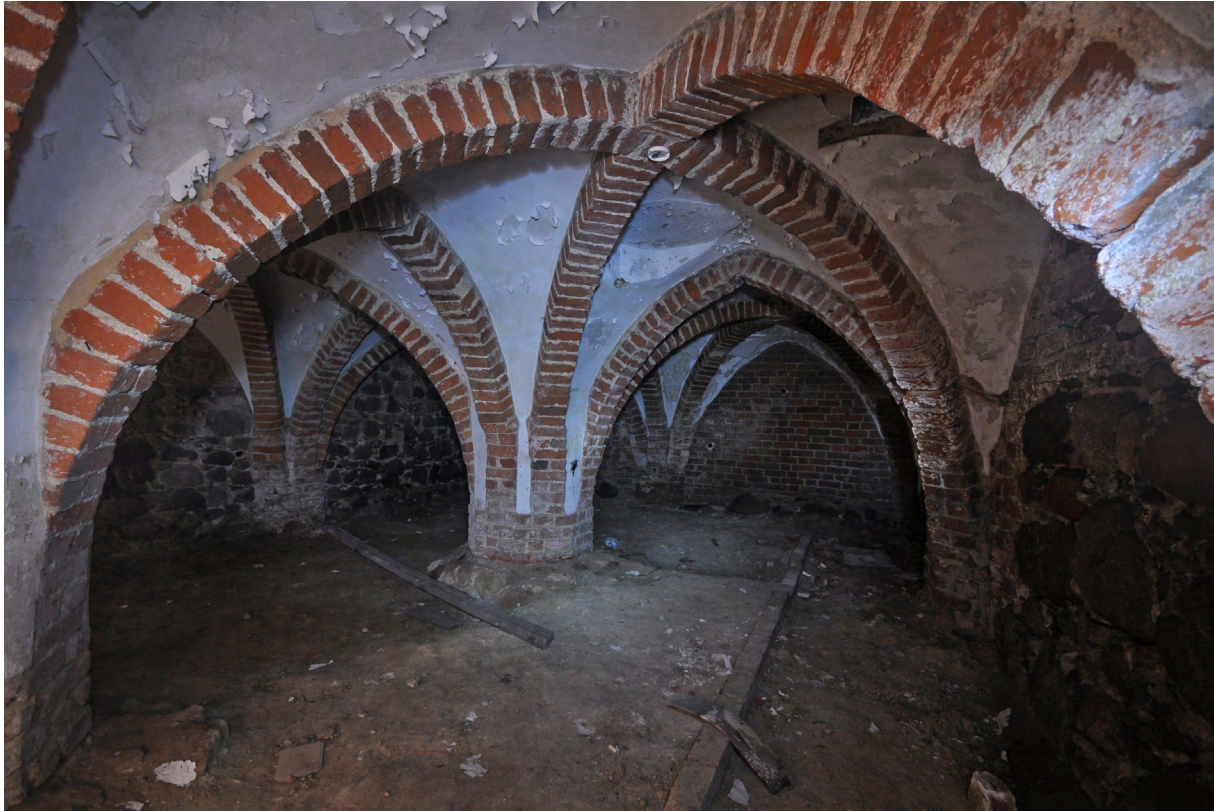
Fig. 13. Cellar of the south-western wing (photo B. Wasik).

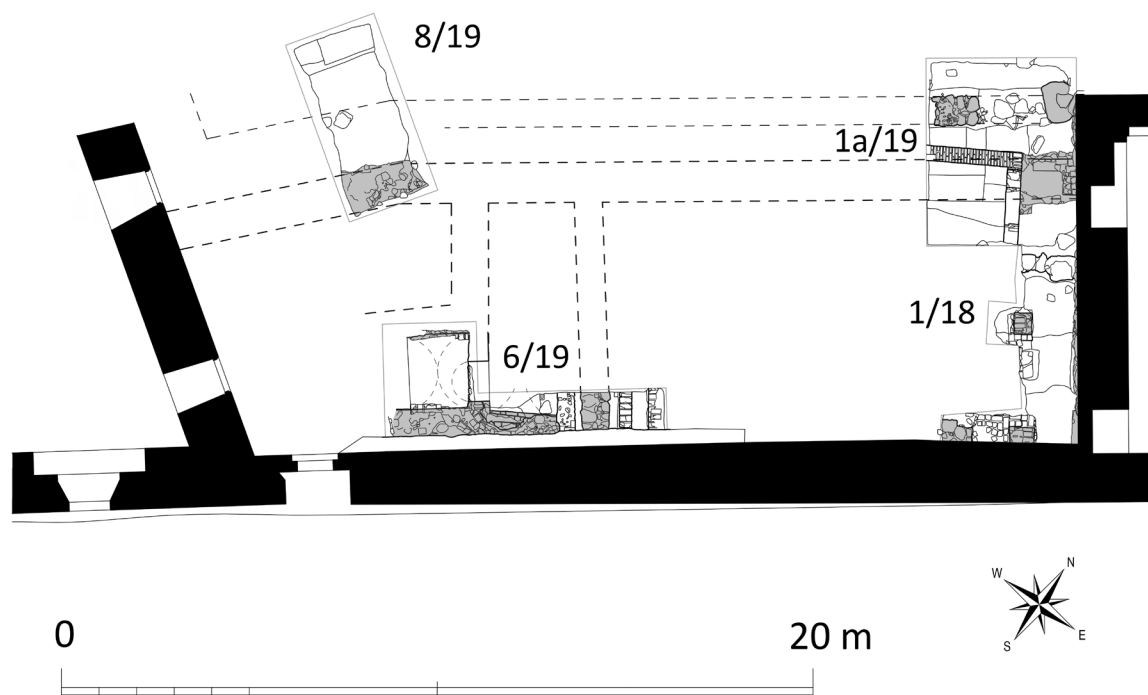
Fig. 15. Plan of the remains of the Grand Masters' gemach. The medieval walls discovered in the trenches were marked in grey (by B. Wasik).

Analysis of the discovered relics reveals two phases of the *gemach's* construction (Fig. 15). First, a rectangular building was built in a length of about 16.5 m, which did not reach the south-western wing. In the second phase, however, the building was extended so that it took up the entire space of 22–24 m between its neighbouring buildings. The added extension narrows to the southwest, because the wall from the courtyard was set at a different angle so as not to cover the window of the south-western wing. Apart from this change in the wall angle, another construction technique and foundation level point to biphasic activity. The foundation of the wall for the first phase of the *gemach* is carefully built of layered stones, while in the second phase the wall was made much less neatly, with mortar poured abundantly on it. The location of the cellar staircase is also decisive. As a result of the extension of the building, it was located in the interior of the building. As a standard, such stairs were situated on the outside (accessible from the courtyard). On the remains of the walls and the staircase vault, there are no traces indicating that the vault would continue inside the new part of the *gemach*. This proves that it was originally a staircase outlet (with a quarter-arch profiling of the arch) leading to the open stairs outside the building (Fig. 16).

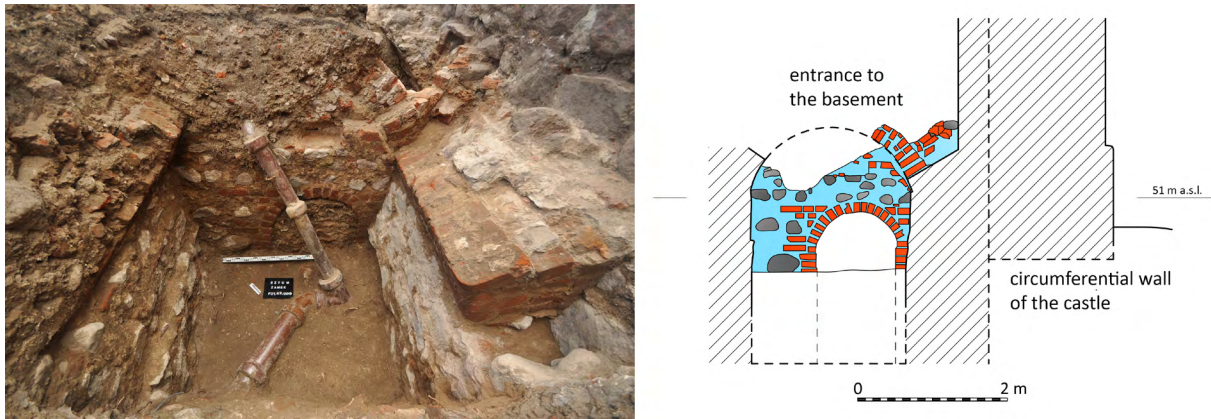
Fig. 16. The entrance to the gemach's cellar uncovered in trench 6 (photo B. Wasik, drawing P. Kujawa, digit. B. Wasik).

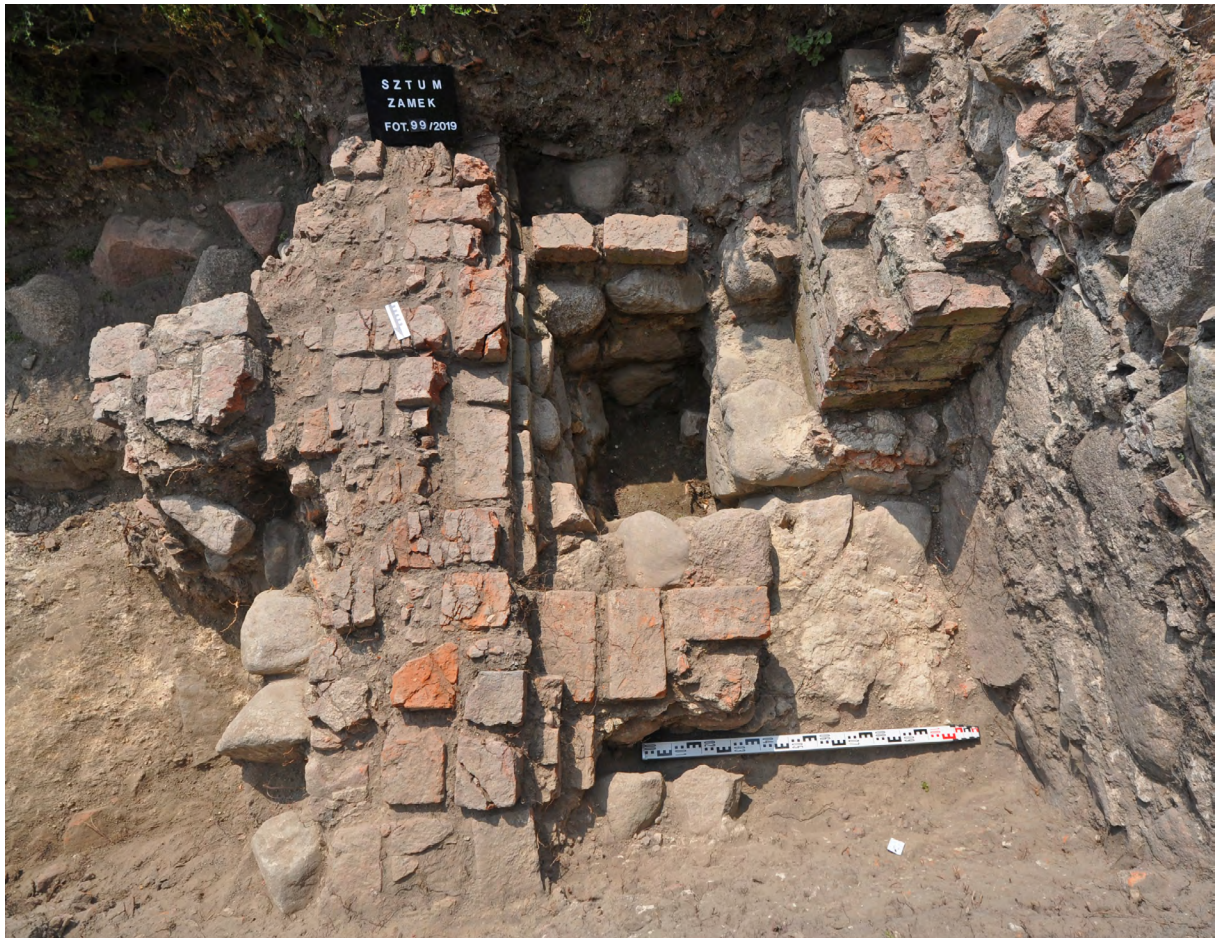
Fig. 17. West wing – remains of a presumable bakery oven from the 16th–17th century discovered in trenches 4-4b. At top right, a relic of the arcade pillar of the castle defensive wall (photo B. Wasik).

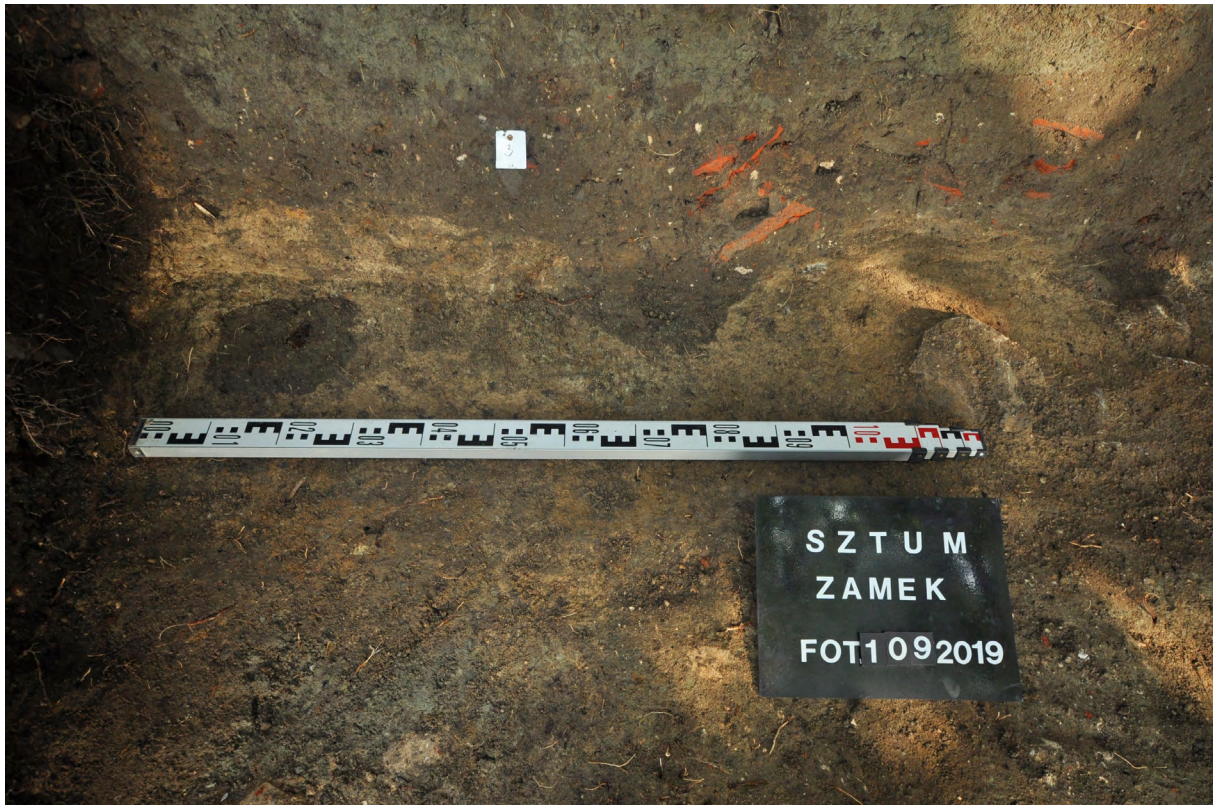
Fig. 18. Trench 11 – negatives of palisade piles (photo B. Wasik).

surrounded the entire castle on the inside of the moat. The negative of this construction was documented in trenches 7 and 11 (Fig. 18). In the former, it was in the form of a continuous furrow about 25 cm wide, while in the latter, clear circular negatives of sharpened piles were documented. This palisade was constructed in a distance of about 4.7 m from the castle wall in the upper part of the slope. According to the Swedish plan, there was probably one more palisade line below on the banks of the moat.
