Vibration-based health monitoring of lighting poles

P. Steinbauer^a, Z. Neusser^a, I. Bukovský^a

^a Faculty of Mechanical Engineering, Czech Technical University in Prague, Technická 4, 160 00, Praha 6, Czech Republic

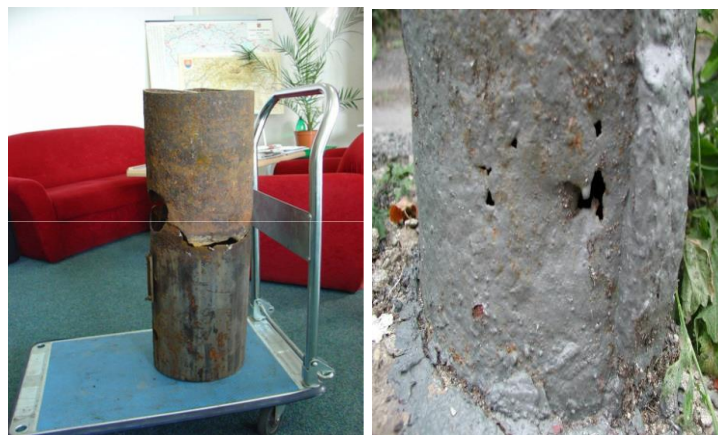
The corrosive damage of the pole occurs usually at the pole base, often under the surface. The corrosion on the top of the pole is less frequent. In any case, the damage is not apparent and localizable (Fig. 1).

Fig. 1. Damaged lighting poles

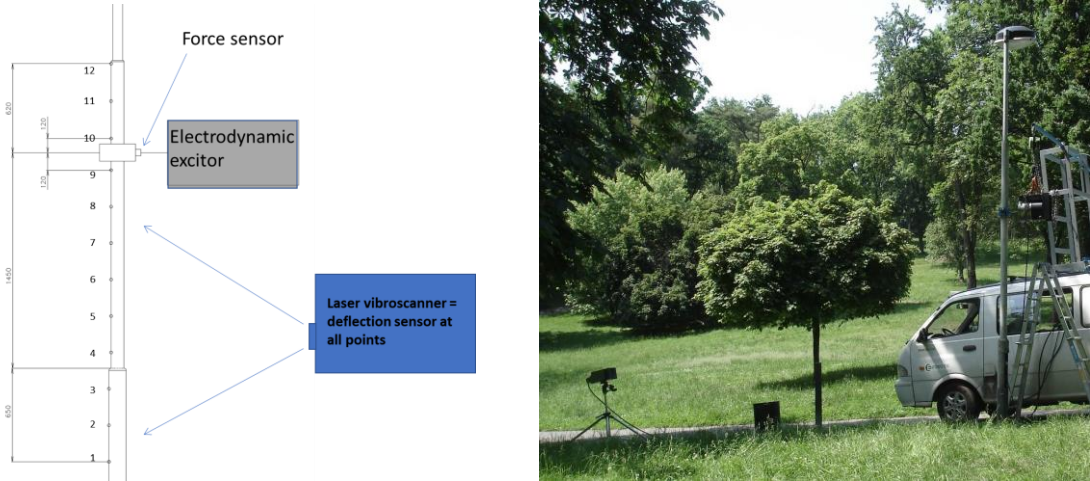
Fig. 2. Measurement setup for experimental modal analysis of lighting poles

The promising modelling results had to be verified experimentally. The two sets of existing, installed poles with same design, dimensions and arrangement, but quite different health, were selected. The complete experimental modal analyses were carried out for each pole in the investigated set. The first set was laboratory installation, fixed into the concrete bed, the second pole set consisted of regularly installed poles (same dimensions), i.e. in the sand bed. The excitation force was introduced by electromechanical shaker connected through load cell mounted on the pole in the height 3m. The pole response was measured by scanning laser vibrometer at several points on the pole (Fig. 2). The setup was same for all poles in the set.

The results in the form of frequency response functions (FRF) that were measured at the point 10 (see Fig. 2) are demonstrated in Fig. 4.

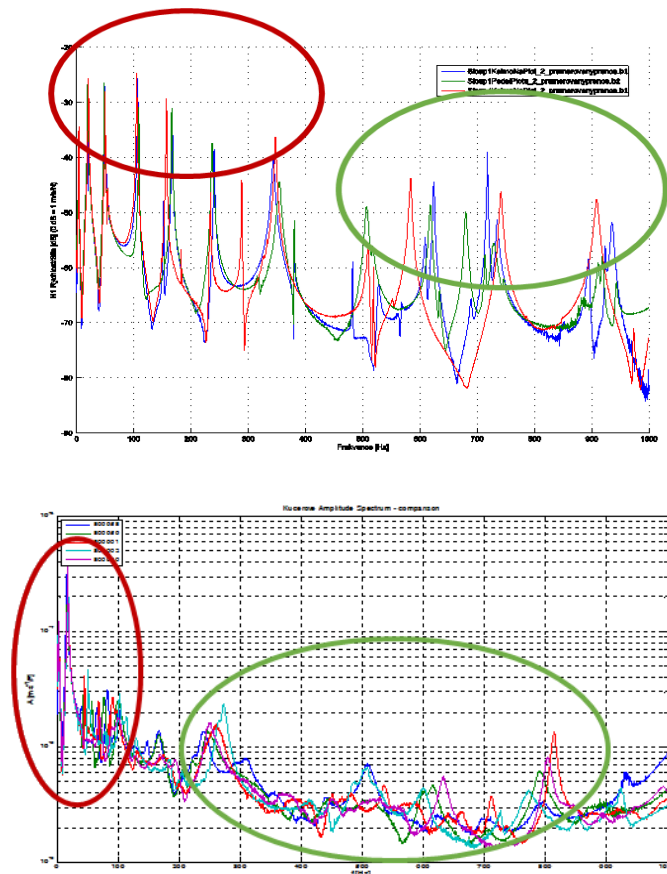
The concrete bed set has very low damping and eigen frequencies can be clearly visible. The frequency shift is almost negligible in the lower frequency range, but the frequency shift can be easily distinguished in higher frequency range. The regular set (sand bed poles) was heavily damped in all cases and some of pole eigen frequencies were not detectable due to high damping or position of measurement. But still, the higher frequency range of eigen frequencies exhibited a detectable frequency shift.

Fig. 3. Frequency transfer function of the lighting pole (a) in the concrete bed (b) in the sand bed

Many eigen frequencies, especially in higher frequency range must be taken into evaluation of the pole damage, which makes the evaluation more robust against the influence of soil, sand damping, pole damage location and the location of selected excitation and response measurement point. A single frequency, especially the first eigen frequency, does not provide us with solid information about structural damage of the pole.
